# Ecological Approaches to the Stabilization of Civil War Earthworks

*The following article is abstracted from Archaeological Site Stabilisation and Reconstruction in the United States by Kevin Jones. The full report is a significant and comprehensive guide to site stabilization. It presents the results of 1993 field visits to more than 25 separate earthworks locales in nine states to examine sites from the Paleo-Indian period through the Civil War. Study objectives included methods for recording and assessing damage, vegetation management, and physical techniques for protection. Mr. Jones' work was supported through a Winston Churchill Memorial Fellowship. The Fellowship recognized the nationally-important need to preserve and protect earthworks associated with Maori history and culture, as well as the practical significance of international information exchange.*

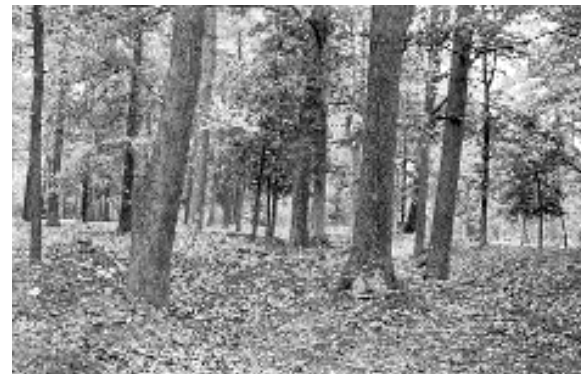
Cold Harbor, Richmond National Battlefield Park. Confederate trenches under open oak/hickory forest. The forest floor here has been cleared of shrubs; the soil is acid and infertile; only mosses and thin grass grow with some oak seedlings in foreground. How will the protective forest canopy last in the long term unless such seedlings are selectively allowed to grow? Photo by the author.

Cold Harbor was the scene of fighting in 1862 and 1864 over an 11 km-long front with only 150 acres today reserved in the park. The lines of the Confederate and Union armies in 1864 consist of more or less parallel lines of trench and breastwork, three and four ranks deep, taking advantage of low ridgelines. Toward the northern part of the unit, where the opposing lines are close together (and many thousands of Union soldiers were killed or injured), the surface has had all shrubs removed to reveal the form of the trenches. Soils are clayey and are of poor fertility. The near-ground plant cover is particularly thin, consisting of a few strands of grass and mosses, caused by the lack of light and fertility and high soil acidity. Happily, visitors follow the road and generally respect the signage asking them to stay off the earthworks.

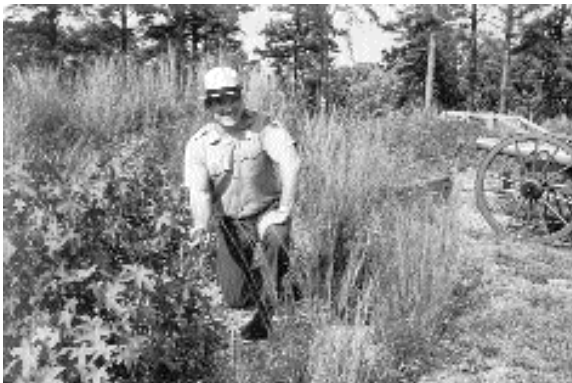
Successful establishment of little bluestem on Battery 5, Petersburg National Battlefield Park. The invasive shrubs (e.g., sweet gum at left) may be removed by burning or hand-weeding. The age of establishment is approximately 2 years and the grass now offers good protection. The figure is John Davis, park interpreter. Photo by the author.

Battery 5, a simple breastwork enclosure with embrasures (earthwork enclosures for gun emplacements), is close by the park visitor center and maintenance complex. It has been cleared of tree cover many times in the past, with the result that it has stood in a pine (probably loblolly, *Pinus taeda*) successional stage for much of the time. There had also been repeated attempts to lime the acid soils under the pine trees and to establish fescue K31. This had failed due to drought, acidity and shade; the effect here was probably not dissimilar to that described previously for the open parts of Cold Harbor in the Richmond National Battlefield. The main grass which established here was crab grass (*Digitaria sanguinalis*). There was extensive wear from visitor usage.

The recommended prescription from Andropogon Associates had been: (a) repair of eroded areas (by applying topsoil), (b) mulching and overseeding with fescue K31, a clover, and *A. scoparius*. I was advised that fescue K31 only had been sown, and not the native grasses, the latter being a quick adventive in all old fields in Virginia. However, I believe that the *A. scoparius* must have been sown or plugged to achieve the density that I saw. Although attempts have been made to correct fertility and acidity problems, *A. scoparius* has invaded naturally on the failure of the fescue and has competed successfully with the annuals. Vines (principally honeysuckle and blackberry), tree saplings (pine, probably *P. taeda*, oak, sweet gum *Liquidambar styraciflua*, wild cherry *Prunus* sp.) and sedges are establishing on the slopes of the

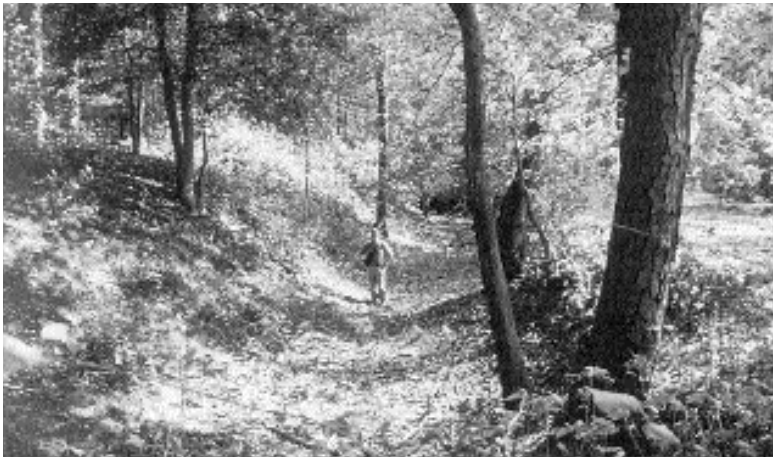
Fort Fisher, Petersburg. A young oak-hickory-holly forest cover on the earthworks. There are plentiful seedlings re-generating on the banks and a loblolly pine (*Pinus taeda*, a clue to the young forest age) at right. A high winter water table in the ditch (centre) kills off any plant growth. Photo by the author.

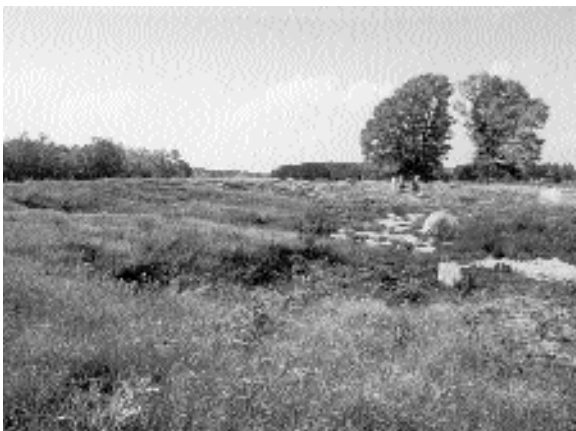
Confederate Fort Gregg, Petersburg. Site of a recent conversion from pine oak-hickory forest to grassland. The site on clearance was top-dressed with topsoil and planted in the annual grass, winter rye (now dead). Later, the site was planted in perennial fescue varieties which will come through the adventive summer annual crab grass (prominent here). Little bluestem will come in as an adventive and compete well with the fescue on south-facing banks. Photo by the author.
